RE: Report – Limited Indoor Air Quality (IAQ) Assessment with Fungi Sampling
Site: Representative Areas of Floors 1 - 5, 101 Friendship Street, Providence, RI 02903
RI Analytical Laboratories, Inc. Project #2025112

1 INTRODUCTION

3.1 Photographs of Representative Site Conditions Observed.

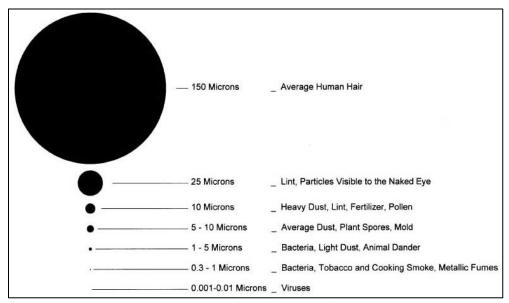
Figure 1 - Visual PM Comparison Chart

The EPA's health-based National Ambient Air Quality Standards (NAAQS) for PM₁₀ is 150 μ g/m³ and for PM_{2.5} is 35 μ g/m³ (both measured as a 24-hour period concentration) for outdoor (ambient) air. The **OSHA**² Permissible Exposure Limit (PEL) for occupational exposure for total nuisance dust is 15 mg/m³ for an 8-hour time-weighted average (TWA) and for the fraction of respirable dust is 5 mg/m³ for an 8-hour TWA.

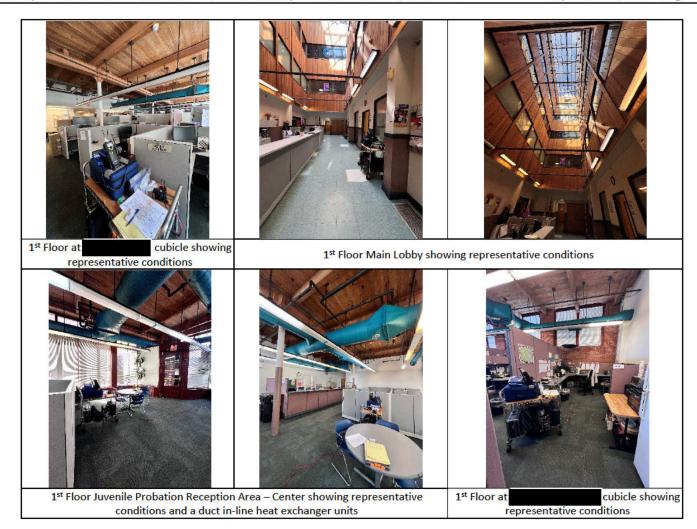
1st Floor at cubicle showing representative conditions and a duct in-line heat exchanger unit

- ➤ Visible dust and debris, as identified in the representative surface sample collected, was observed on air supply and return registers throughout the areas sampled, and likely also present throughout the building. Inspection and cleaning are needed. All HVAC system components including ducts, coils, condensate pans, and supply and return registers should be cleaned thoroughly. Improved housekeeping and maintenance are recommended. Follow SMACNA³, NADCA⁴ and IICRC guidelines. HVAC system filters should be regularly replaced.
