Evaluation of indoor environmental quality with limited surface sampling for metals at an office building

Health Hazard
Evaluation Program

Report No. 2018-0046-3346
March 2019

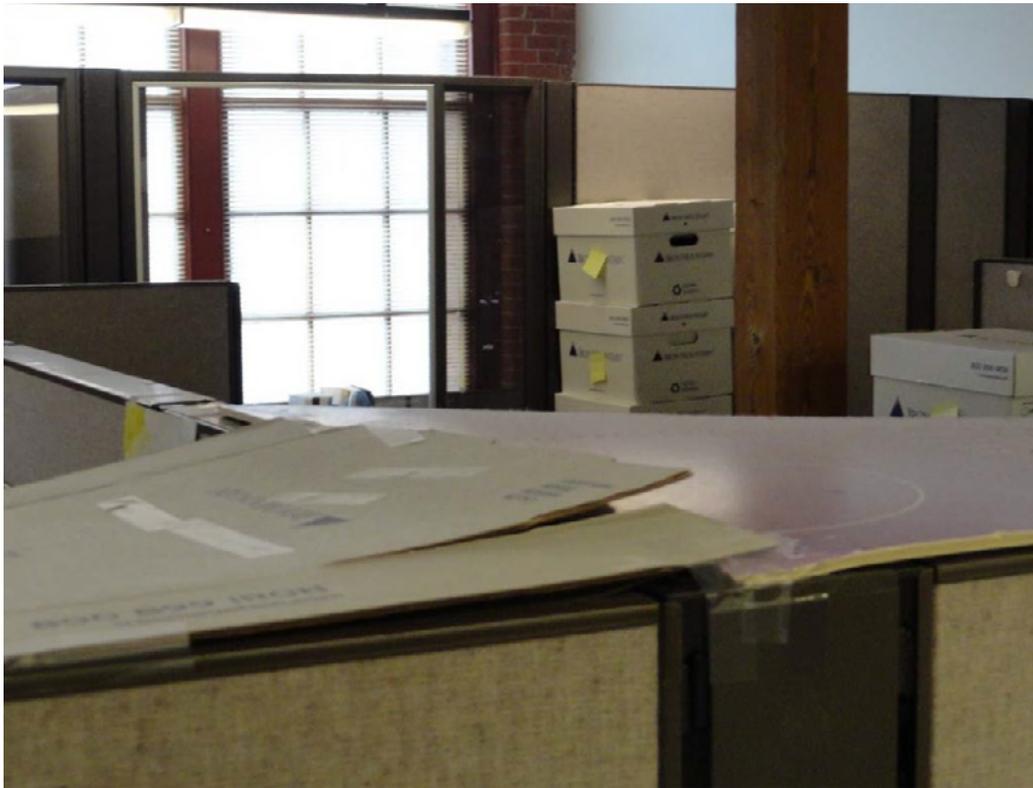
Figure B3. Personal workspaces partially covered with poster board to block dust from heating, ventilation, and air-conditioning system at an office building on June 1, 2018. Photo by NIOSH.

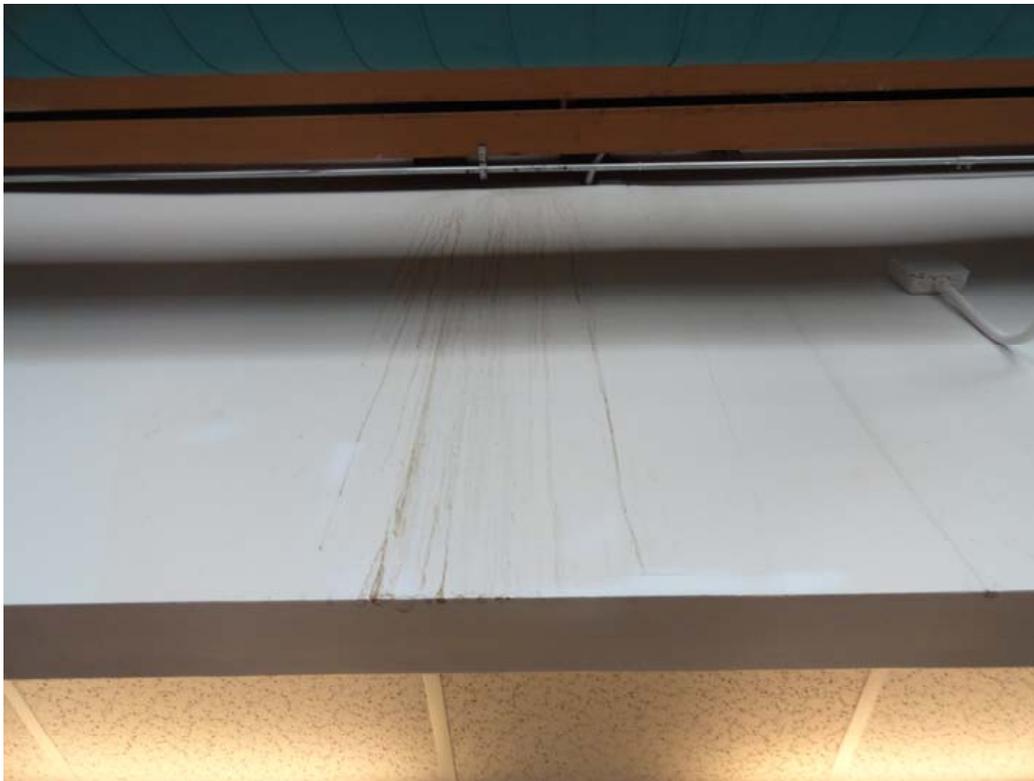
Figure B4. Evidence of recent water damage at an office building on June 1, 2018. Photo by NIOSH.

We saw evidence of recent water damage during the walkthrough. We also observed potential sources of water in individual workspaces such as fish tanks. Research has found that damp building conditions can lead to respiratory illnesses in occupants. Dampness in buildings can occur for a variety of reasons such as high indoor humidity, condensation, and roof leaks. Damp building conditions promote the growth of mold, bacteria, and other microbial agents, as well as dust mites and cockroaches. Dampness can also contribute to the breakdown of building materials and furniture. Musty odors are a sign of microbial contamination. Building occupants in damp buildings can be exposed to pollutants in the air from biological contaminants and the breakdown of building materials.

4. Maintain indoor temperature and relative humidity levels according to the guidelines discussed.
 5. Routinely inspect the building for water intrusion and damage and correct these upon discovery. During and after heavy rains, walk through the building and check for water incursion.

- a. Identify any potential sources of dampness or mold through visual inspection and make proper repairs to prevent further problems from occurring.
 - b. If dampness or mold is not identified during visual inspections but is suspected because of musty odors or continued health complaints, consider other methods (e.g., infrared camera or borescope) to look for hidden problems.

- c. Monitor repaired areas to ensure repairs and remedial actions are effective.
 - d. Keep a record of when and where mold or water-damaged materials are discovered and what has been done to promptly fix the underlying problem leading to the water damage.
